# Manhole Inspection Summary

Manhole # S09UU\_008MH

**Location** Address: **3402 FAIRVIEW AVE**

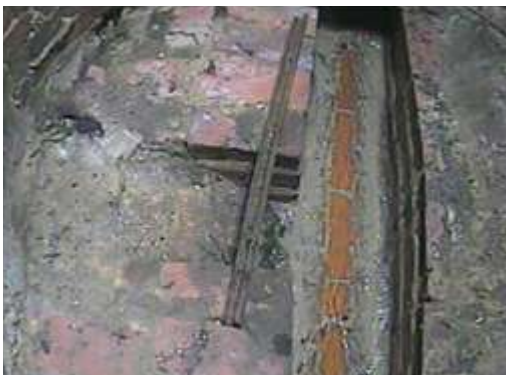
Defect 2

Condition: ☐ Sound ☐ Cracked ☐ Root Intrusion ☐ Deteriorated ☐ Leaks ☒ **Debris**

DEBRIS ON BENCH.

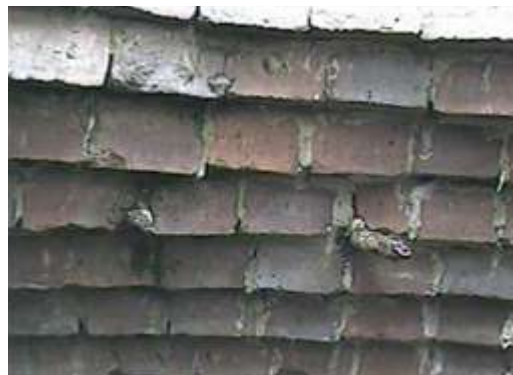
Defect 1

**Steps** Count: **4** Missing: **1** ☒ **Corroded**

CORRODED/MISSING RUNG

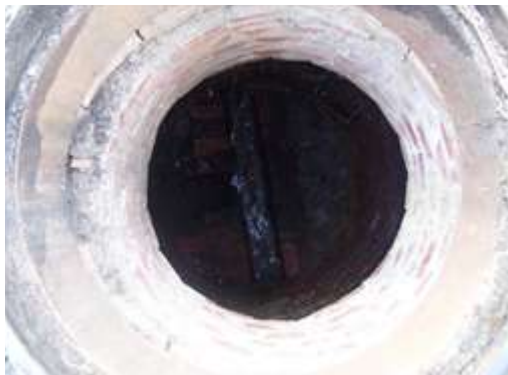
Defect 4

Condition: ☐ Sound ☐ Cracked ☐ Root Intrusion ☒ **Loose Brick** ☐ Deteriorated

LOOSE BRICKS AT FRAME  
ADJUSTMENT

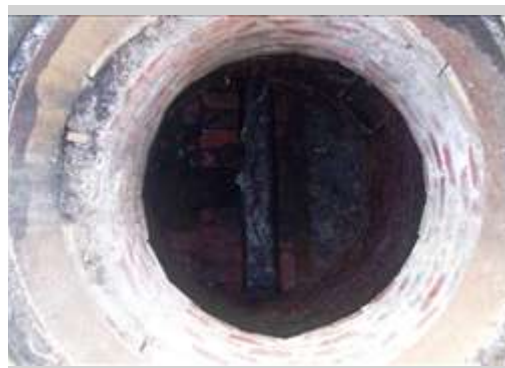
Defect 3

**Frame** Offset: **2** (in.) Condition: ☒ Sound ☐ Cracked ☐ Leaks

OFFSET FRAME

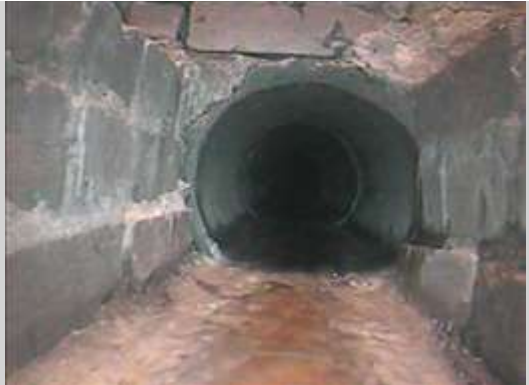
12 O'Clock Outflow

8 in. Circular Gravity Sewer  
Pipe Out @ 12 O'Clock

Pipe Height: (in.) Direct  
Pipe Material: **Clay** ☐ Pipe Lined  
Invert Depth: **9.88** (ft.) Flow Characteristics: **Slow**  
Deposits: ☒ None ☐ Mud ☐ Sludge ☐ Debris ☐ Grease  
Silt Depth: (in.) Deposits Extent:  
Infiltration: **None** Pipe Seal Cond: **Sound**

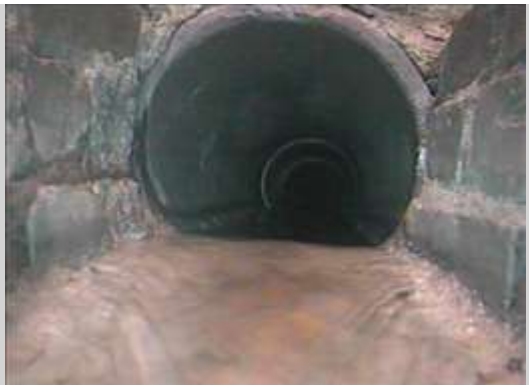
6 O'Clock Inflow

8 in. Circular Gravity Sewer  
Pipe In @ 6 O'Clock

Pipe Height: (in.) Direct  
Pipe Material: **Clay** ☐ Pipe Lined  
Invert Depth: **9.65** (ft.) Flow Characteristics: **Slow**  
Deposits: ☒ None ☐ Mud ☐ Sludge ☐ Debris ☐ Grease  
Silt Depth: (in.) Deposits Extent:  
Infiltration: **None** Pipe Seal Cond: **Sound**
